## Planning a Resilient Road Network for Jalandhar and its Peripheral Areas

Simran Tyal \*, Ambika Arora\* and Manpreet Singh Saini\*\*

\*7<sup>th</sup> Sem. Civil Engineering DAV University Jalandhar, (PB), INDIA

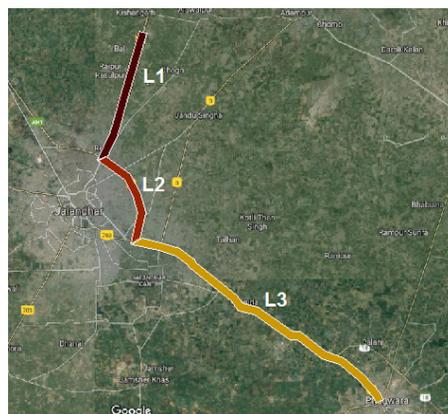
Fig. 5. Survey Locations.

**Section L2: Pathankot Chowk - P.A.P Chowk (N.H-1 and N.H-44 Starting point)**

**Section L3: P.A.P Chowk - Phagwara (N.H-1)**

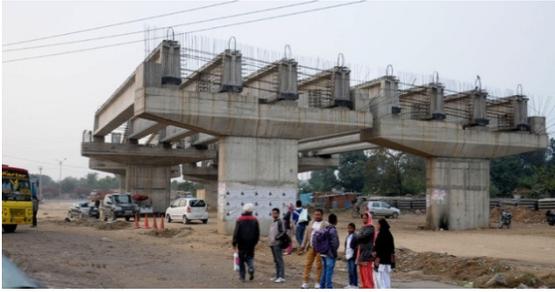
Many bridges and under passes lies incomplete even after 7 years of commencement of the project. Due to incomplete structure the road stretch has been made vulnerable to various road accidents.

**Fig. 7.** Incomplete structures at P.A.P Chowk.

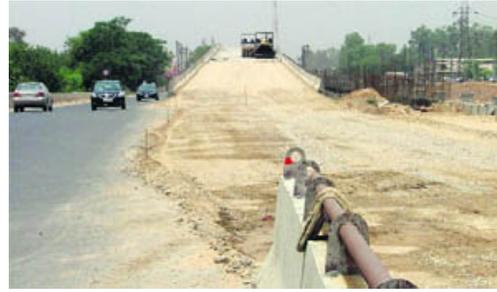
**Fig. 8.** Incomplete flyover.

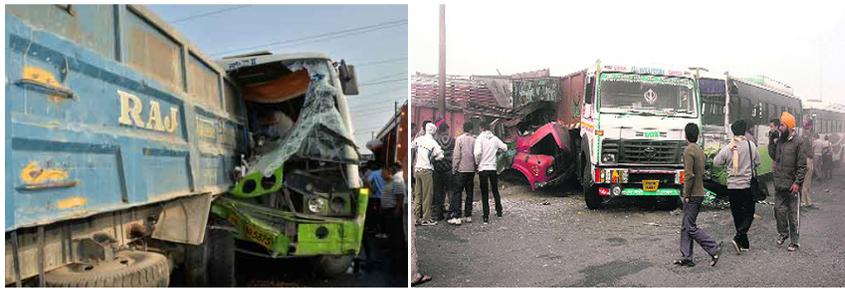
**Fig. 9.** Some of the major road accidents on the road.

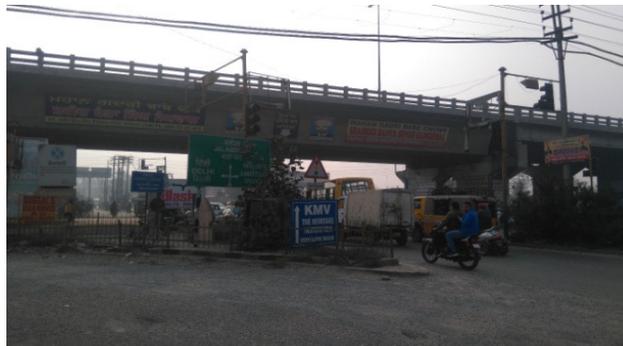
**Problem:** It is observed that at every junction there is a slip lane for free left turns. There are no safe pedestrian crossings across these slip lanes and no holding area in the triangular islands. This leads to pedestrian vehicle conflicts and potentially unsafe situations. Also, on signalized junctions, no pedestrian phase is included in the signal cycle and there are no pedestrian signals. The junction area is large and medians do not run up-to the junction and this can lead to undefined moments.

**Fig. 10.** Pathankot Bypass.

**Recommendation:** Junction design needs to incorporate safe pedestrian crossing elements, including pedestrian crossing phase in the signal cycle. Also pedestrian signal should be installed at the junctions to better guide pedestrians. Junctions should be made tighter so that movements are clearly defined and at the approach road a channelizing island must be installed since the vehicles do not move on them as evident by the dust marks.

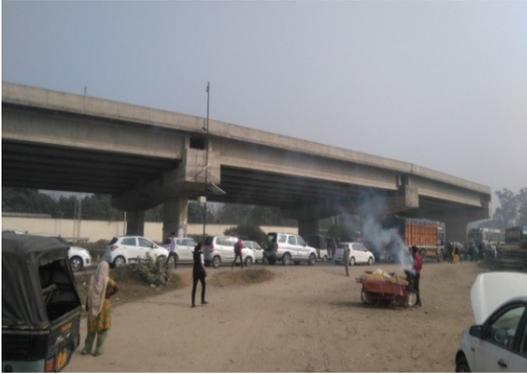
**Problem:** The slip lanes are generally very long, which allows vehicles to make left turns at high speeds. This is dangerous for pedestrians that need to cross the slip lanes in order to access the junction islands, where they have to wait, in order to cross the road.

**Fig. 11.** P.A.P Chowk.

**Recommendations:** Provide a speed hump just before the crossing for all long slip lanes. Alternatively, provide a raised pedestrian crossing, which also acts like a speed hump, and allows for pedestrians to cross without having to step down and up.

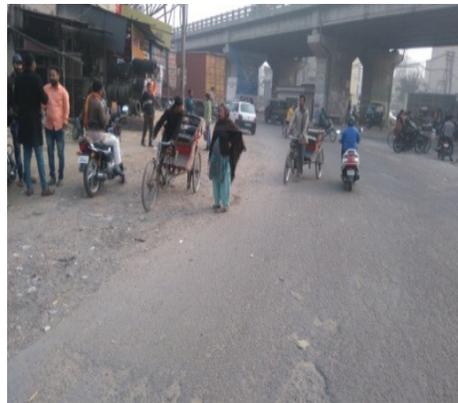
**Problem:** In some stretches along the corridor, there are no footpaths. The space designated for the footpath is covered by debris, forcing pedestrians onto the carriageway.

**Fig. 13.** Missing Stretches of Footpath.

**Recommendation:** Provide a complete and continuous footpath along both sides of the corridor.

A footpath with frequent breaks will tend to not be used by pedestrians and are prone to encroachments. The minimum clear walking width of at least 1.5 meters, (excluding all obstacles such as vendors, street utilities, trees, etc.) must be maintained throughout

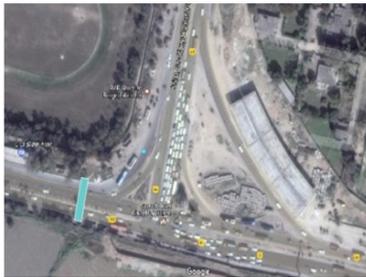
**Problem:** High number of vehicles at this junction due to major road intersection has resulted in many major

accidents including passengers waiting for buses at road sides.

**Fig. 16.** Proposed FOB at P.A.P Chownk.

**Recommendations:** Provide FOBs with direct connections with all major roads.

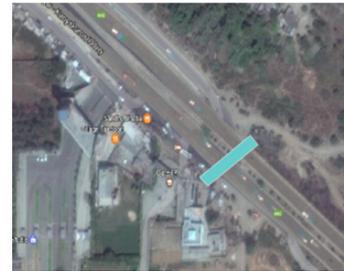
**Fig. 17.** Proposed FOB in front of LPU Gate 1.

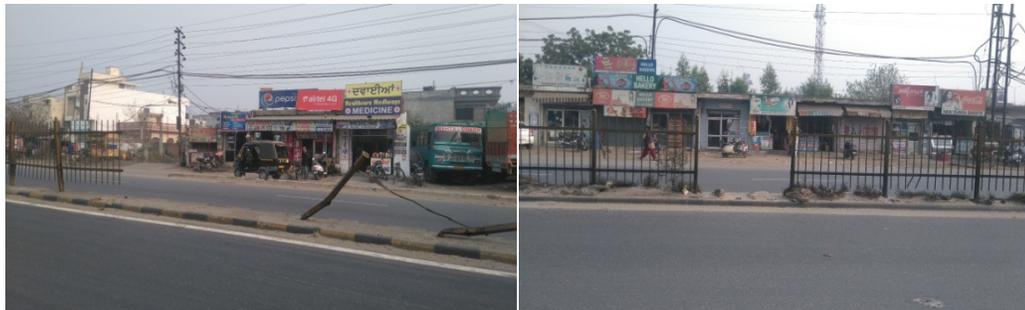
**Problem:** Due broken railing on road divider it makes the already tough journey more difficult on this stretch. The railing which were broken due to vehicle collision are not repaired and are not removed from the site which further makes the road more prone to accidents.

**Fig. 18.** Broken railing on road dividers.

**Recommendations:** The railing on the road must be changed with concrete crash barriers or with steel railings which can withstand a direct impact from a truck.

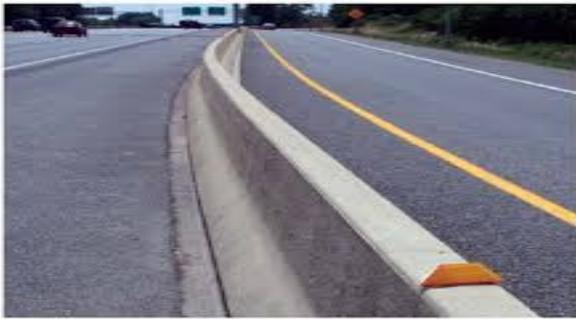
**Fig. 19.** Use of Concrete Barrier.

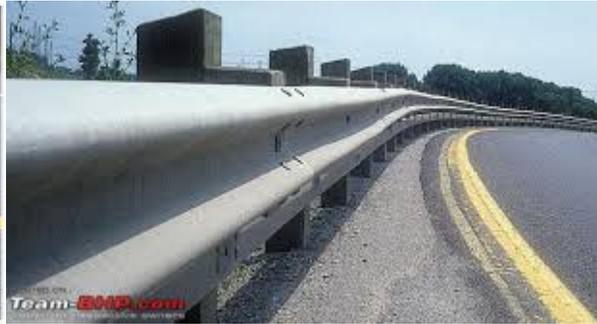
**Fig. 20.** Use of Steel Barrier.

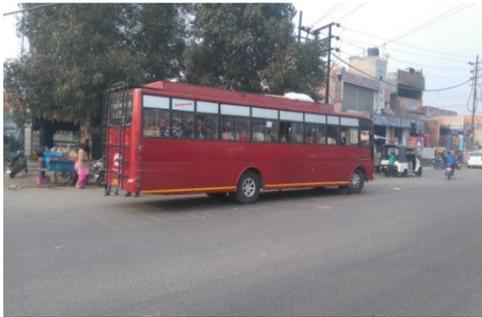
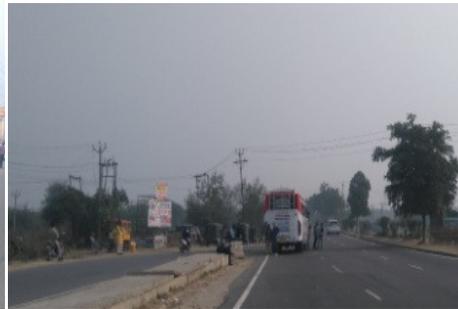
**Problem:** Un-organized queuing of buses on the road obstructs the traffic on the stretch and at intersections queuing of buses lead to the traffic jam at slip ways. Due to fast traffic flow at the slip ways of intersections sudden stops of buses in such a traffic flow causes accidents.

**Fig. 21.** Unauthorized parking on National highway.

**Recommendations:** Bus lay bays should be provided at regular intervals so that traffic is not obstructed by the buses.

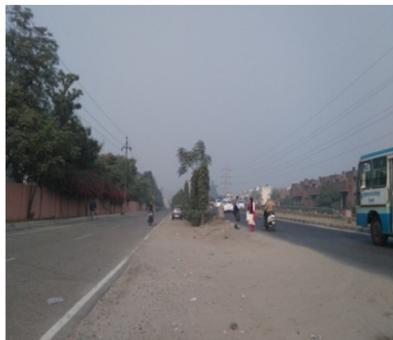
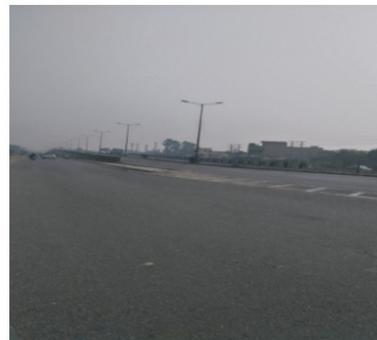
**Problem-**If vehicles stay on the right side of the road vehicles would have to take a U-turn from the other end of the flyover and this adds up in the distance and wastes

time ultimately. Vehicles may collide to the curbs due to non-availability of signboards.

**Fig. 22.** Missing Sign Boards.

**Recommendations:** Sign boards should be provided before the curbs between the flyover and service road begins as this will signify the beginning of curbs as well.

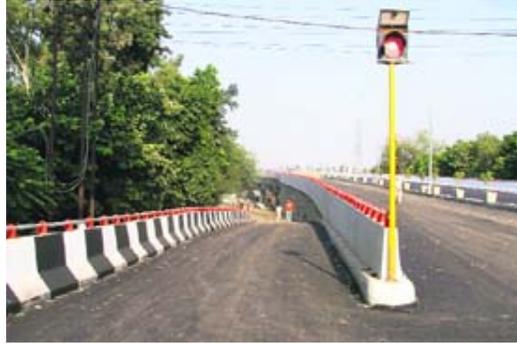
**Fig. 22.** Well planned road marking.
