Soil Quarrying for Brick Kiln and Its Impact on Environment: A Study in Tufanganj Block-I, Koch Bihar, West Bengal

Nazrul Islam

Assistant Professor, Department of Geography,
Sitalkuchi College, Sitalkuchi, Cooch Behar, West Bengal, India.

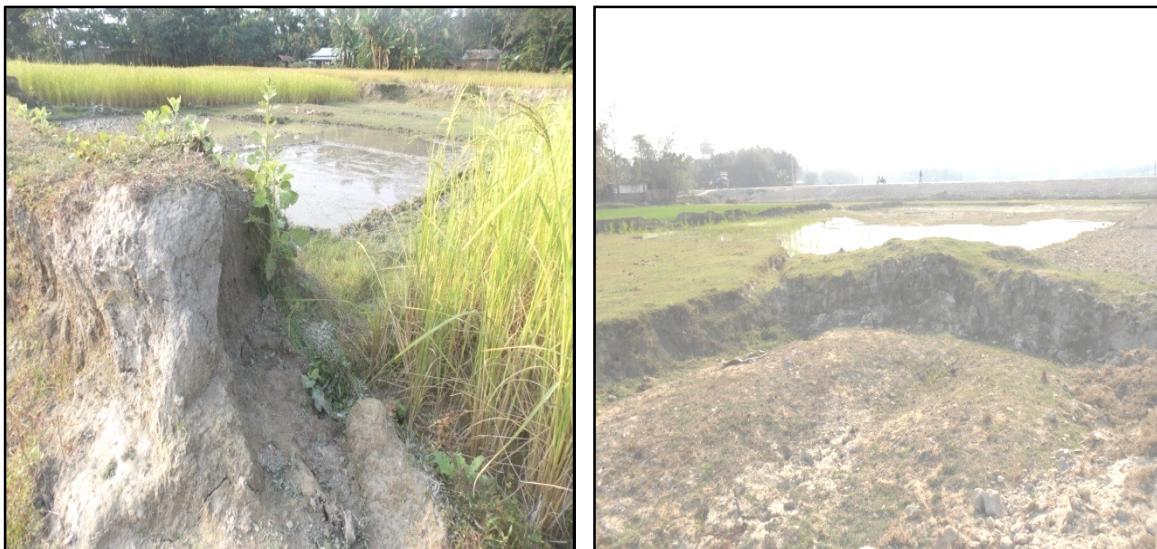
Photo Plate-1 and 2: Land Degradation due to Soil quarrying.

Due to the excessive quarrying of land, the adjacent land remains in high position as compared to the quarried land. It creates a serious problem for the adjacent highland as the water is drained to the lower land. Consequently, during the time of cultivation, the major portion of that irrigated water is drained away towards the lower land. It usually needs much water to the upper land comparative to lower land because of being rapid draining out of the water.

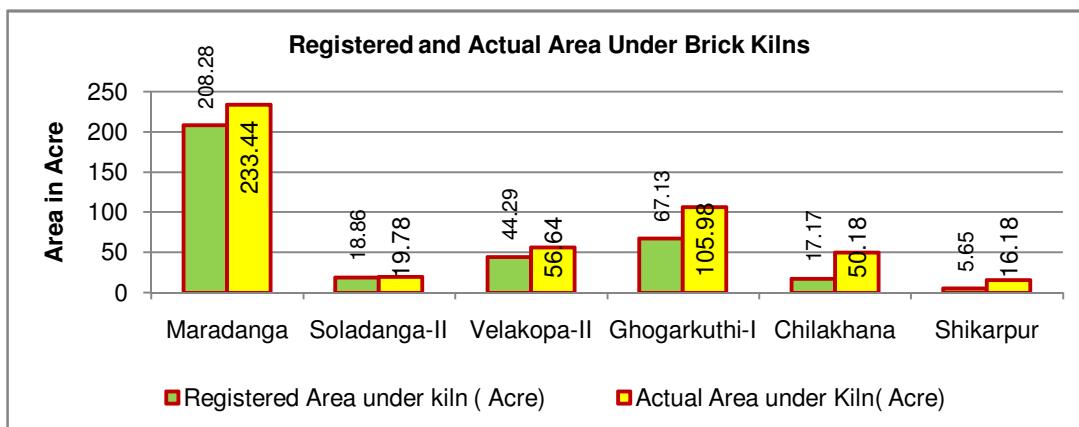
Fig. 1. Registered and Actual Area under Brick Kilns.

It is evident from Table 1 and Fig. 1 that the total area registered under different kilns in different mouzas of the study area has changed over time. The owners

submitted the documents in the DL & DLRO office, Koch Bihar under brick kilns records lower than the actual land. The actual land found by the researcher has been measured by GPS Oregon eTrex 550. The average rate of change is about 75%. The rate of change is maximum in Soladanga-II mouza (95.34%) followed by Maradanga mouza (89.22%). The minimum change is noticed in the study area in Chilakhana mouza. Table 2 shows that the total area covered by the brick kilns is 359.45 acre and 58.61-acre land has been degraded in different mouzas in the year 2015-16. (Fig. 2 and 3).

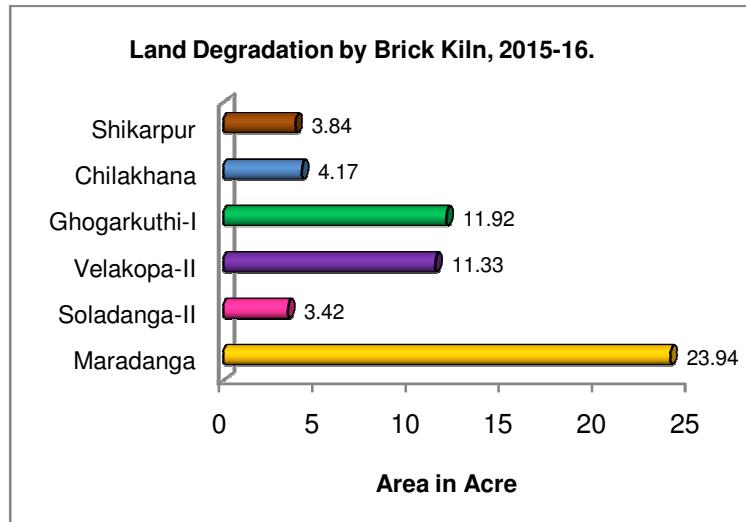
Fig. 2. Land Degradation.

Maradanga and Shikarpur mouzas having 1198.46 acres and 290.03-acre net sown area (NSA) in which 21.46 acre and 3.42 acre (with 2 feet depth) are quarried or degraded. 27.78-acre land is being removed in every year in two mouzas. In other Mouzas, topsoil has been degraded in the same way. In Soladanga-II (1.20%), Velakopa-II (1.02%), Ghogarkuthi-I (0.43%) and Chilakhana (0.28%) have also been degraded.

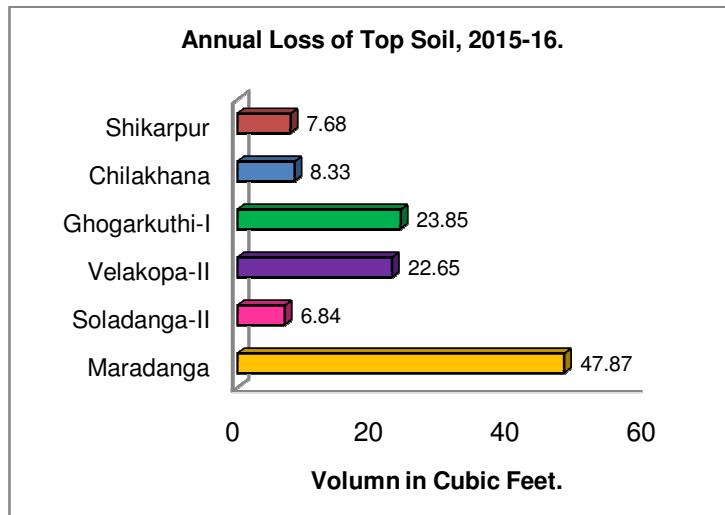
Fig. 3. Annual Loss of Top Soil.

The total number of brick kilns is 24 which are located in the above-mentioned 6 mouzas. The total consumption of the topsoil during the session 2015-16 was 117.22 Cubic feet (cft) and they will keep on consuming this amount soil in every year. Fig. 2 shows that the highest

consumption of soil was observed in Maradanga mouza (47.87 cubic feet), followed by Ghogarkuthi-I (23.85 cubic feet), Velakopa-II (22.65 cubic feet), Chilakhana (8.33 cubic feet), and Soladanga consumes 6.84 cubic feet in 2015-16.

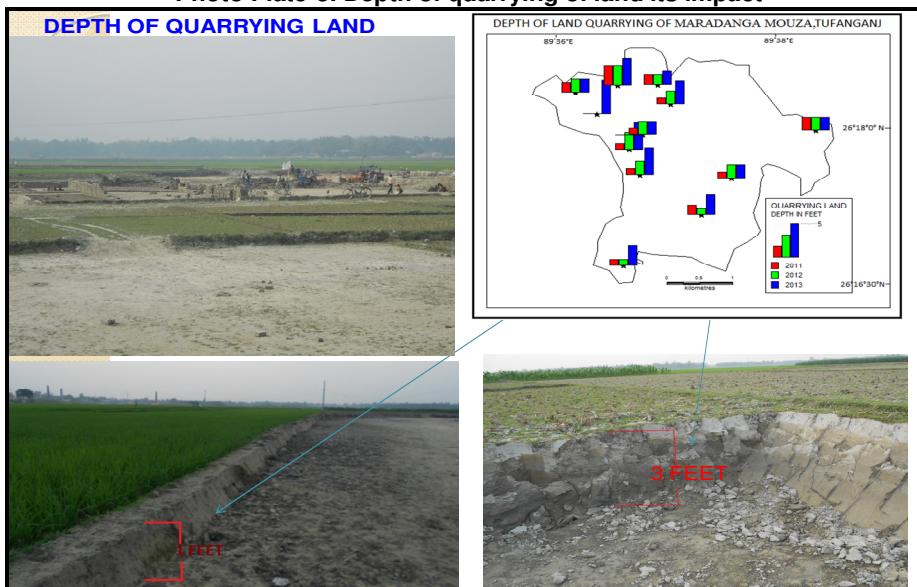
2. The Depth of Quarrying Land: The process of quarrying is gradually spreading more widely. As a result, all the lands are becoming lowered by soil quarrying. Sometimes some of the land owner make lower than the adjacent land. The farmers cut down 1.5 feet while the neighboring land is cutting down by 1 foot.

So the same problem has resulted. In the same way, the depth of quarrying land is deeper from 1 foot to 2 feet, 2 feet to 3 feet, 3 feet to 4 feet and on words. It is very alarming that the quarrying is repeatedly increasing. It is treated as an ulcer or septic wound.

Photo Plate-3: Depth of quarrying of land its impact

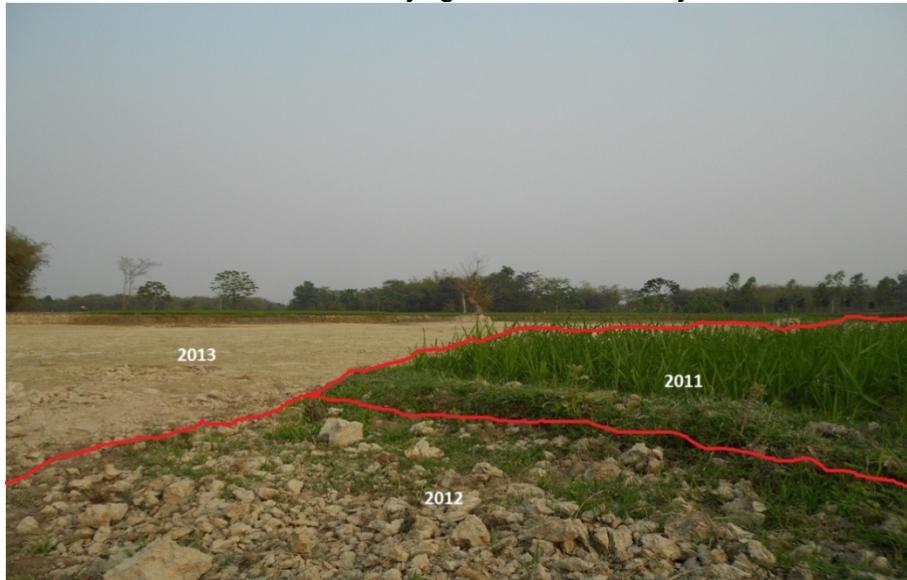
Photo Plate 4: Quarrying of land in different years.

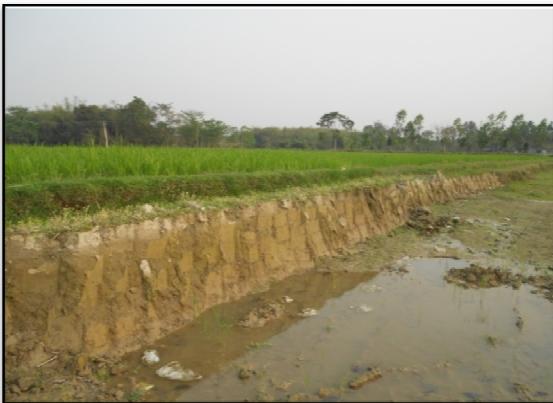
5. The problem of Irrigation: The un-quarried land becomes higher in elevation and hence, difficult for irrigation. During the time of cultivation, the major portion

of that irrigated water is being drained away towards the lower land. So the requirement of water in the higher land becomes much more than the quarried low land.

Photo Plate-7: Problem of Irrigation on the higher land.

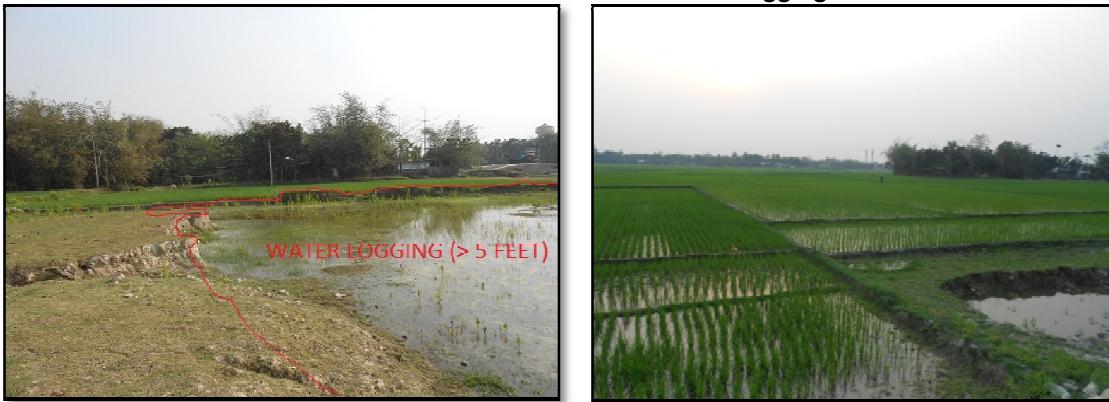
6. Problem of Water Logging: From the field survey, it reveals that water logging in the quarried land is a common problem in the brick kiln area. Water logging is defined as the flooding of land by rainwater [4]. It occurs through water accumulation in the low-lying lands. Water logging is not only in the rainy season but also occasionally take place in the other season. If the land is cultivated, the crop can be spoiled when drowned by the excessive water. Consequently, cultivation of the quarried lands can be the much more risky enterprise.

In many cases, the risk of water logging prevents the land from being cultivated. Inundation of agricultural land is common during the rainy season. Thus, it is difficult to practice the crops because of water logging. After studying the area it is found that Amon is not suitable in the area where the depth of quarried land > 4-5 feet. Moreover, the water logging throughout the year creates some environmental problems as these are the breeding place of mosquitoes and the ecology of the area has been disrupted [7]. The long-term water logging contaminates the underground water.

Photo Plate-9 & 10: Problem of Water Logging.
